# PLEASANT RIDGE

Union School District

## **Facility Improvement Plan** **(2025 Revision)**

*January 13, 2026*  
**COMMUNITY  
ARCHITECTURE**

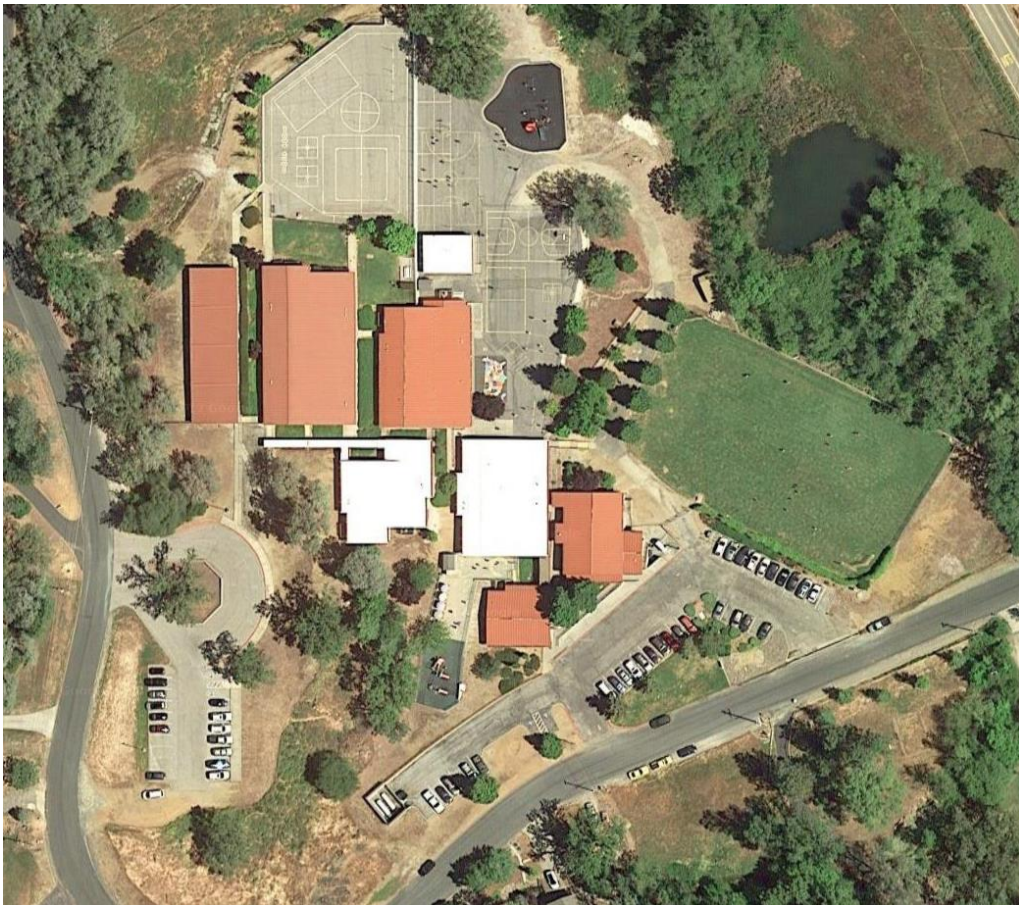
Constructed in two major phases in 1983 and 1991 followed by a single modular classroom building addition in 2002, the campus has a very consistent appearance with regard to architectural features and equally consistent patterns of general wear & tear. The school is well maintained, however the excessive grade level changes (terrain) present special challenges to routine maintenance and care of landscape.

The school consists of 21 Classrooms, Library, Tech Lab, Computer Lab, Administration and Support Spaces, Multipurpose Room and Serving Kitchen, Custodial, Garden Area and Restroom Spaces. Enrollment as of October 1, 2025 is 330 students with a capacity of 525 students at a Teacher-Student ratio of 1:25.

Parking and paved surfaces are in need of resurfacing along with the need to construct bus and auto drop-off areas. Grade and level changes along with limited site area are prohibitive to the creation of easily super-visible and accessible facilities. Existing grades require significant ramp and stair features that are difficult to traverse and costly to modify to meet current code requirements. Common ADA improvements are very difficult to design and construct due to the extreme grades and level changes across the site. Site improvements of any kind will require special consideration of design and approval processes by and between the District, the Design Team and the Office of the State Architect. Strict adherence to the current requirements of the California Building Code is not feasible due to impractical design/code solutions and excessive costs.

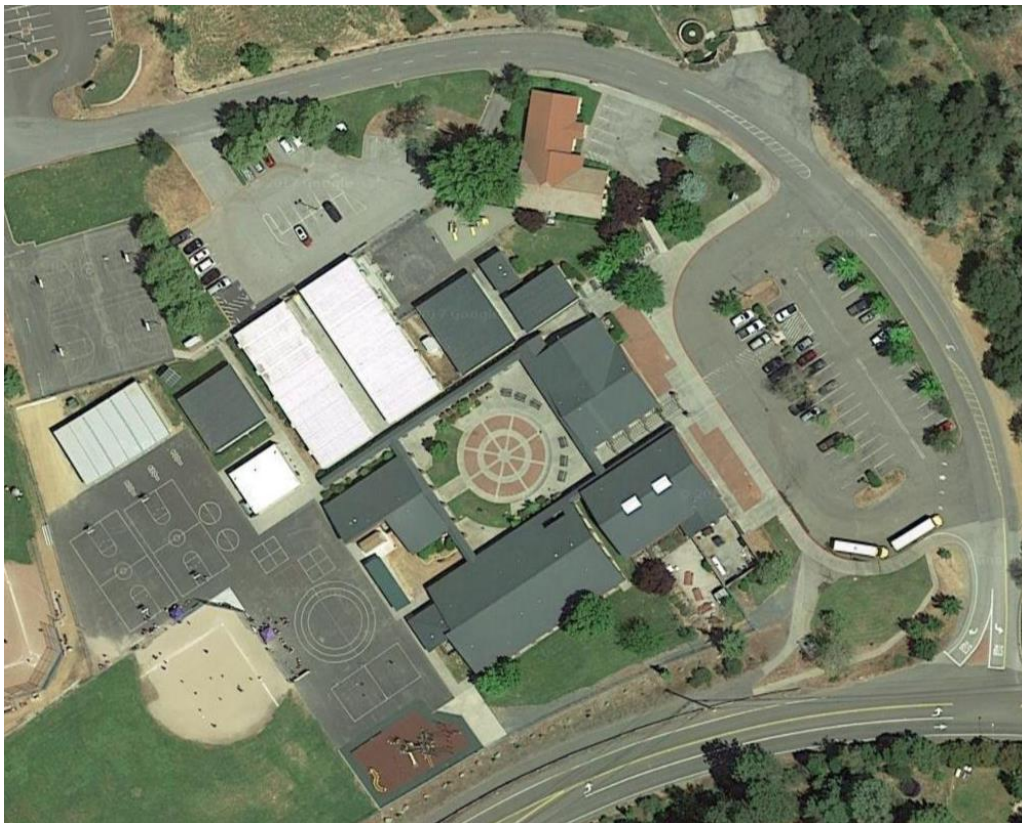
## COTTAGE HILL ELEMENTARY SCHOOL OVERVIEW

The newest of the District's school sites was originally constructed in 1980 as an all-modular (portable) campus, subsequently removed and replaced with new utility infrastructure and new permanent buildings in 1990. The campus was later expanded with modular (portable) classrooms in 2000, 2009 and 2011. The campus design reflects a general feel of consistency and adherence to a basic master plan and overall sense of being well maintained largely due to its relatively recent construction history. In general, the buildings and grounds are in good condition with attention needed at the modular classroom wings.

On site parking is limited with combined bus and auto drop-off areas (preferably separate features) and no provisions for disabled student-loading areas. Pavements are showing signs of aging and failure and are in need of resurfacing or replacement. Striping, signage and accessible parking spaces require improvements.

As compared to the other school sites, Cottage Hill is relatively flat with few barriers due to grade level transitions. This has resulted in easy pedestrian transitions across the campus, with few ramps, efficient use of site area and building placement and the placement of a large outdoor student commons area that is central to the campus, provides a focal point for students and visitors and easily accessed throughout the day for outdoor dining, assembly and promotion events. It is important to note that the flat terrain simplifies future site improvements and significantly reduces the cost of improvements

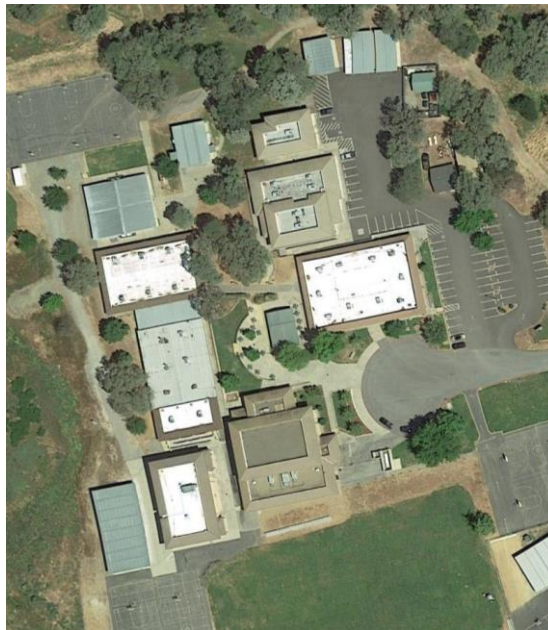
## MAGNOLIA INTERMEDIATE SCHOOL OVERVIEW

Constructed over many phases beginning in 1975 with the remodel and conversion of the Administration Building from a commercial building to school use with permanent (site-built), modular classroom buildings and the addition of portable classrooms added as recently as 2006, the campus reflects many years of stylistic influences and varying levels of wear and tear as compared to the other school sites in the District. The campus is generally in a good state of repair but showing the signs of need for considerable Deferred Maintenance upgrades in the form of roofing, HVAC, floor and wall finishes, and exterior paint.

On site parking is limited adjacent to a combined bus and auto drop-off area (preferably separate features) and no provisions for disabled student-loading areas. Parking and drop-off area also have excessive cross-slope/ADA and pavements are showing signs of aging and are in need of resurfacing or replacement. It is evident that many phases of construction were completed without the benefit of an overall Master Plan for growth, resulting in awkward and uneven sidewalk transitions from building-to-building and associated drainage problems. Although the site terrain is not as significant as compared with Alta Sierra Elementary School, pedestrian access issues related to walkways, stairs, ramps and railings are extensive.

Unlike conventional intermediate school plans, the campus lacks an outdoor gathering or Student Commons space other than the covered lunch area that is filled with tables and benches. Whole-school assemblies, other than in the Large Gym, are not possible with the current plan. Indoor dining is also shared with the functions of the Large Gym, making set-up for physical education and dining a constant issue. As a result a pair of large classroom are used for indoor dining without the benefit of an adjacent Serving Kitchen.

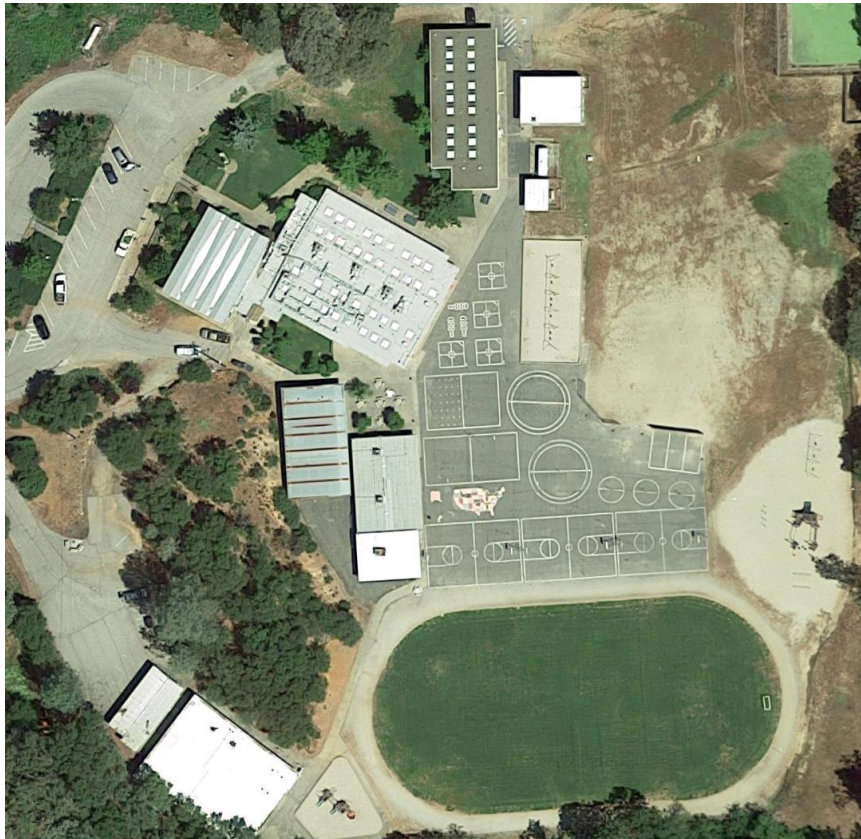
## ARETE CHARTER ACADEMY OVERVIEW

Arete Charter Academy operates as a home-based K-12 charter program on the 10-acre property, owned by the Pleasant Ridge Union School District. As of October 1, 2025, Enrollment stands at 285 students, with a target of 300 students. In this unique model, parents act as teachers with support from staff, educational advisors, guiding students learning from home while supported by the school's campus resources. The site lacks appropriate grade-level facilities.

Despite previous upgrades, the campus faces several operational and site-specific challenges. Parking areas and paved surfaces require resurfacing, and there is a need to develop designated drop-off zones for buses and cars. The site's steep terrain and multiple grade levels create significant accessibility issues, making ADA compliance costly and complex.

Arete Charter Academy currently relies on an on-site septic system and a dedicated well to support daily operations. As part of the district's long-term Facility Improvement Plan, both systems have been identified for major upgrades to ensure compliance with modern standards, increase reliability, and accommodate future enrollment growth.
